**DEPARTMENT OF TRANSPORTATION**

Contract #: 04-0120F4Cty: SF/ALA Rte: 80 PM: 13.2/13.9File #: 69.28**WELDING INSPECTION REPORT****Resident Engineer:**Siegenthaler, Peter**Address:** 333 Burma Road**City:** Oakland, CA 94607**Report No:** WIR-019184**Date Inspected:** 06-Jan-2011**Project Name:** SAS Superstructure**OSM Arrival Time:** 700**Prime Contractor:** American Bridge/Fluor Enterprises, a JV**OSM Departure Time:** 1900**Contractor:** Zhenhua Port Machinery Company, Ltd (ZPMC), Changxing Island **Location:** Shanghai, China**CWI Name:** Liu Hua Jie**CWI Present:** Yes No**Inspected CWI report:** Yes No N/A**Rod Oven in Use:** Yes No N/A**Electrode to specification:** Yes No N/A**Weld Procedures Followed:** Yes No N/A**Qualified Welders:** Yes No N/A**Verified Joint Fit-up:** Yes No N/A**Approved Drawings:** Yes No N/A**Approved WPS:** Yes No N/A**Delayed / Cancelled:** Yes No N/A**Bridge No:** 34-0006**Component:** OBG COMPONENT**Summary of Items Observed:**

On this day Caltrans OSM Quality Assurance (QA) Inspector Subhasis Bera was present during the times noted above for observations relative to the fabrication of the SAS Superstructure being performed by Zhen Hua Port M

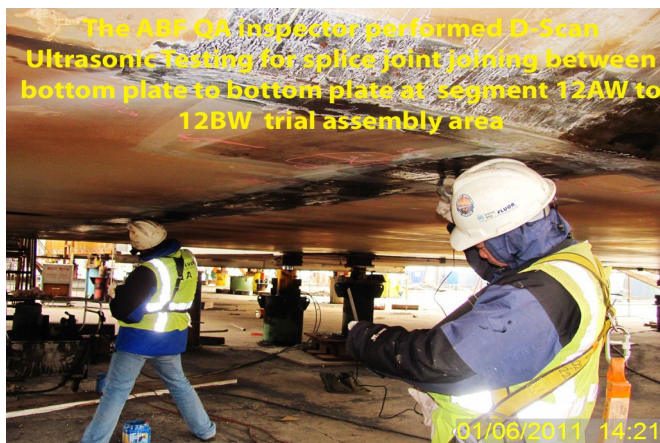
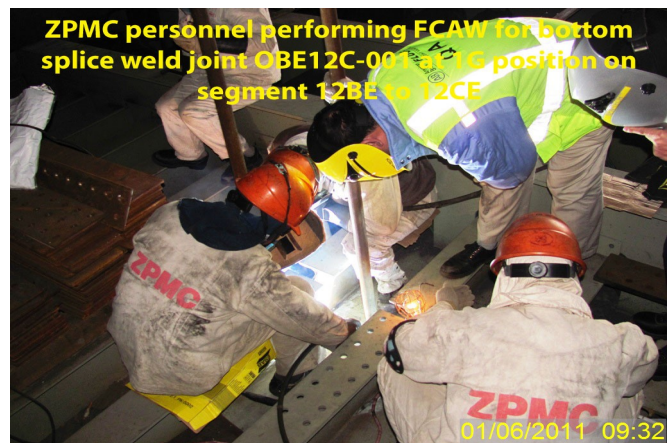
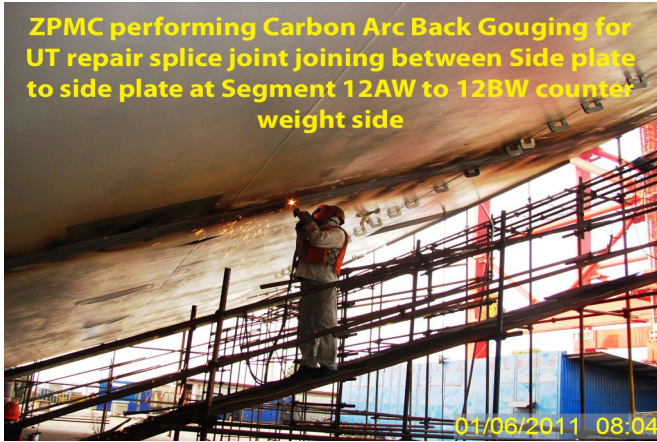
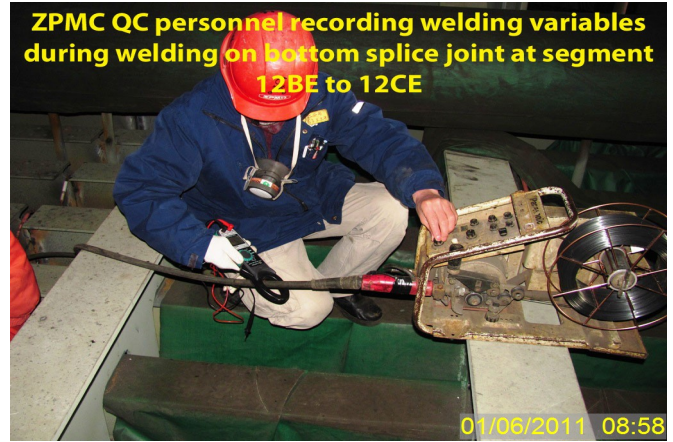
FCAW in the 1G position for the OBG Segment 12BE to 12CE for bottom splice joint weld No.OBE12C-001.

During random visual inspection at trial assembly area , before root pass welding of bottom splice joint OBE12C-001, this QA inspector verified the root opening of this joint and found accepted according to the approved WPS.

SMAW in the 4G position for the OBG Segment 12AE for UT repair joint weld No.SEG3001A-004. The welder is identified as #044515. ZPMC QC is identified as Mr.Wang Li Yang . The welding variables recorded by QC appear to comply with WPS-345-SMAW-4G(4F)-FCM-REPAIR-1. The repair report is identified as CWR2703.

SMAW in the 4G position for the OBG Segment 12BE for UT repair joint weld No.SEG3002A-001. The welder is identified as #050289. ZPMC QC is identified as Mr.Wang Li Yang . The welding variables recorded by QC appear to comply with WPS-345-SMAW-4G(4F)-FCM-REPAIR-1. The repair report is identified as CWR2704.

SMAW in the 4G position for the OBG Segment 12AW for UT repair joint weld No.CA3007-005. The welder is identified as #040656. ZPMC QC is identified as Mr.Zhou Peng . The welding variables recorded by QC appear to comply with WPS-345-SMAW-4G(4F)-FCM-REPAIR-1. The repair report is identified as WR18910.

SMAW in the 4G position for the OBG Segment 12AW to 12BW for UT repair joint weld No.OBW12D-002. The welder is identified as #046709. ZPMC QC is identified as Mr.Zhou Peng . The welding variables recorded by QC appear to comply with WPS-345-SMAW-4G(4F)-FCM-REPAIR-1. The repair report is identified as CWR2709.

SMAW in the 4G position for the OBG Segment 12AW to 12BW for UT repair joint weld No.OBW12D-001. The welder is identified as #046709. ZPMC QC is identified as Mr.Zhou Peng . The welding variables recorded by QC appear to comply with WPS-345-SMAW-4G(4F)-FCM-REPAIR-1. The repair report is identified as CWR2707.

- The component for verification Were identified as CA3012-009,OBW12-001 and OBW12-002 (12AW to 12BW deck panel field splice weld @ A1,A2 and A10)
- Weld repair was to be performed on location where rejectable indication was observed during Ultrasonic Testing (UT)
- ZPMC QC Zhou Zhog Hai was present on site to direct and record all repair work.
- WPS to be used for repair were WPS-345-SMAW-1G(1F)-FCM-Repair-1 and WPS-345-SMAW-4G(4F)-FCM-Repair-1
